DESCRIPTION OF WORK

Job #47647763

Diagnostic Report (Beamer_Break_Room_1)

Diagnostic Report (Hanson_Break_room_1)

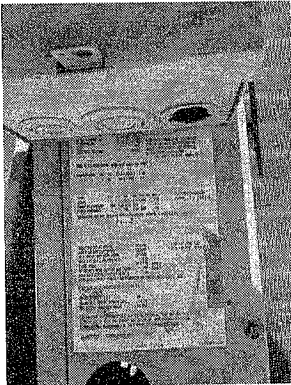
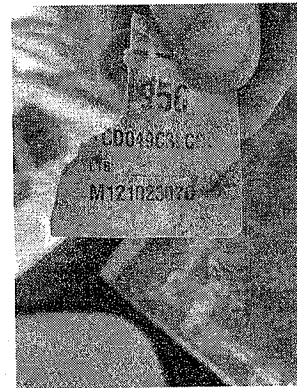
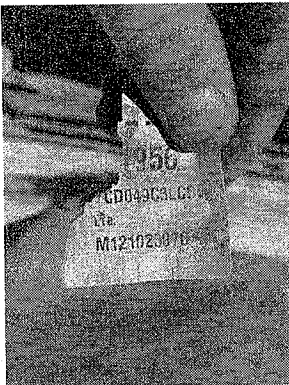
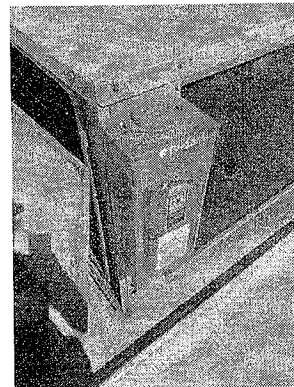
Data Plate

Trane

YCD049C3LCBB-

1997

Package Unit

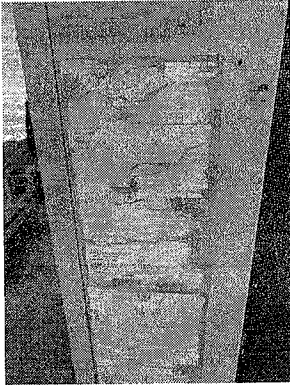
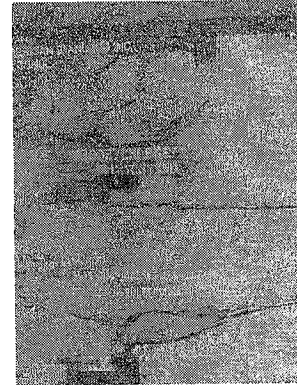
Data Plate

Trane

YCD037C3LBBE

03/1997

R-22

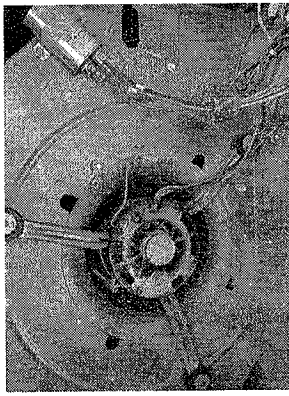
Picture of Blower Motor

System making weird humming sound

Found blower motor seized up. Motor will need to be replaced. Also recommend getting blower

Office needs to order part.

Office will schedule follow up once we have ordered part

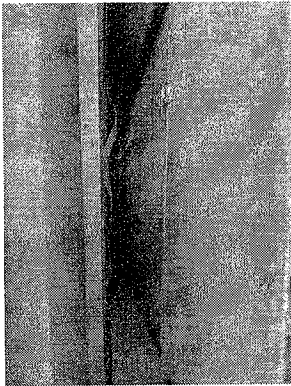
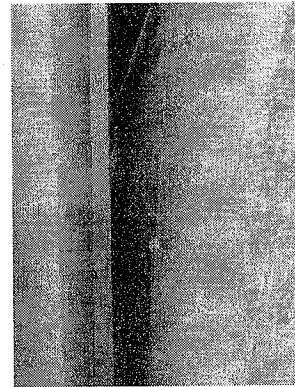
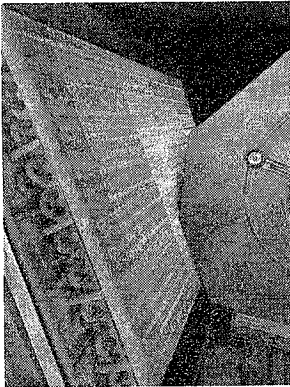
Picture of Indoor Coil

Hanson Break Room 1- Found blower motor seized up. Motor will need to be replaced. Also recommend getting blower wheel cleaned and evap coil cleaned when we do the replacement
 System is also from 1997 and uses old, and restricted refrigerant. Possibly look at replacing
 Beamer Break Room 1 RTU11- Found nob for thermostat was upside down so the desired input was different then the actual input. Rotated knob and system is now operating properly
 Beamer Lobby unit RTU10- Edward mentioned issue with this unit, there is definitely an issue, did not have time today to diagnose
