SCANALYST 3 Report

Verification Report

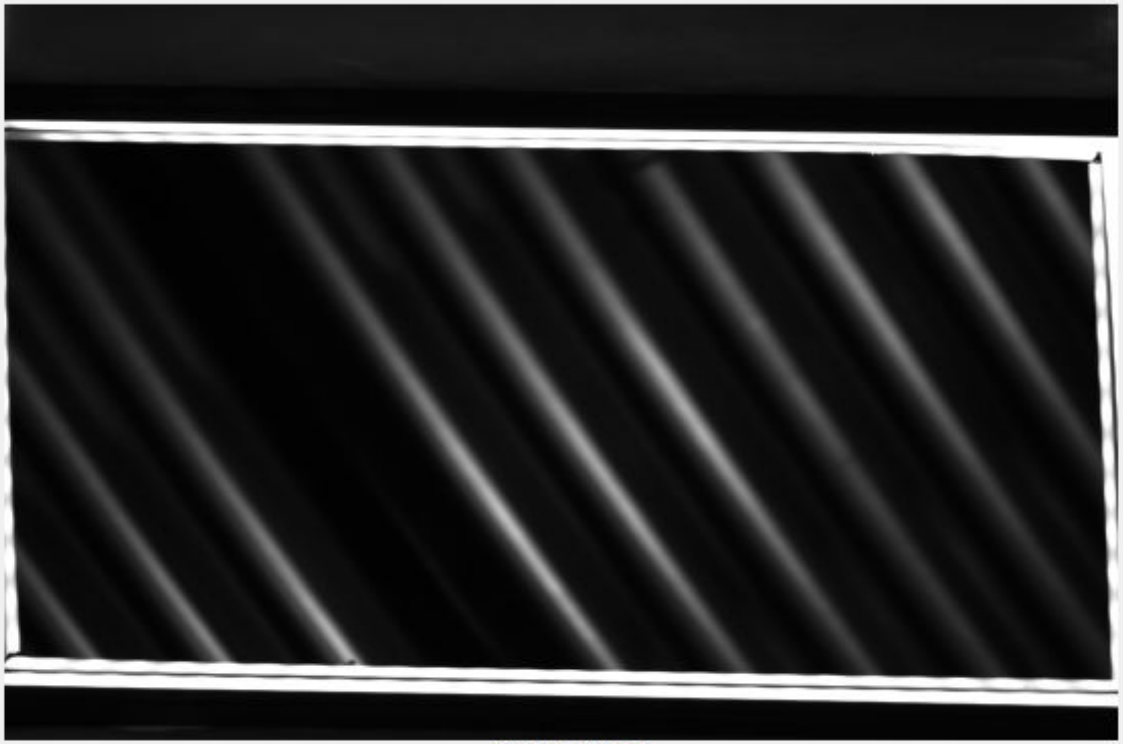
Inspected Image

Barcode Print Quality-Overall	Unreadable
Barcode Data Content	00006757167033064492
Barcode Physical Detail	Physical Details are not available when the SSCC is manually entered

This barcode could not be read or verified. The SSCC barcode data had to be key entered
