Job #43444179

## Diagnostic Report ([B1] RTU\_15 sn: 344D (No heat))

No heat

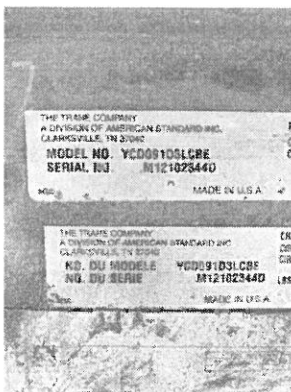
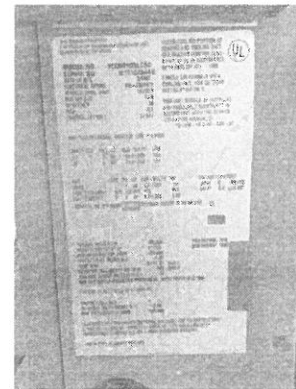
### Data Plate

Trane

YCD091D3LCBE

M12102344D

1997

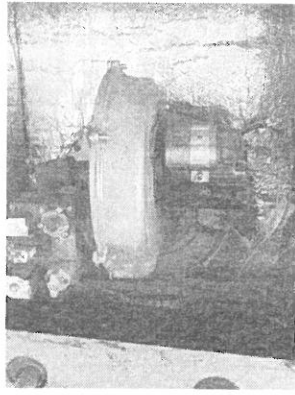
## Additional Pictures

Inducer motor is receiving power but motor is completely seized up. Capacitor is in range and motor is hot to the touch. This motor is a complete assembly with the housing and wheel that would need to be replaced. This is a preliminary repair, there may be issues beyond just the motor. Due to the age of the system and the potential cost/availability of repairs, it's highly recommended to consider unit replacement. Diagnostic fee will be waived upon approval of an estimate.

Schedule Comfort Advisor.

We will see if we can locate the inducer motor and assembly and provide an estimate for the
